KYLE DAM

NDI I.D. NO: PA-417

PHASE I INSPECTION REPORT  
NATIONAL DAM INSPECTION PROGRAM

JUNE 1979

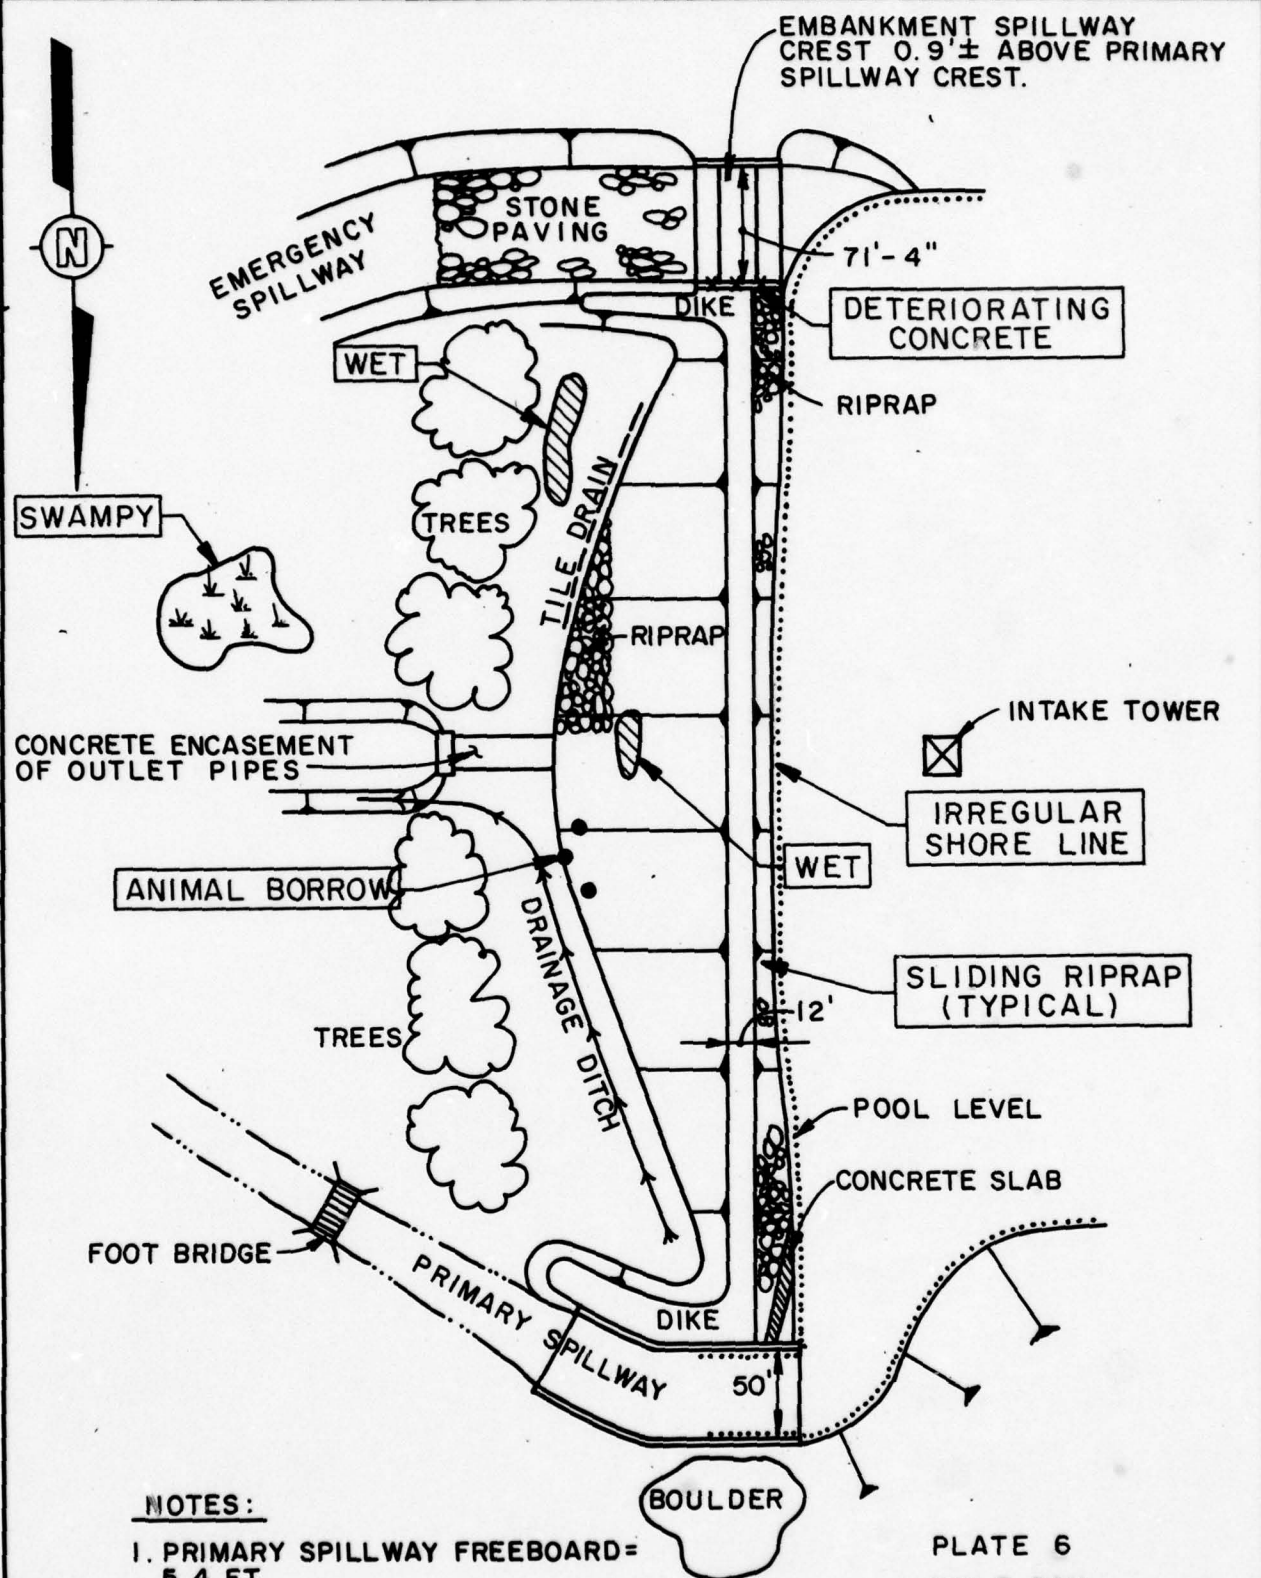
The crest of the dam was surveyed, relative to the primary crest elevation, and it was found that the middle one-third of the embankment has settled by approximately one foot relative to the abutments. The low spot on the crest was found to be approximately 5.4 feet above the primary spillway crest elevation. The dam crest profile is illustrated on Plate 7.

1. PRIMARY SPILLWAY FREEBOARD = 5.4 FT.
2. POOL LEVEL DATE OF INSPECTION: 0.4 FT. ABOVE SPILLWAY CREST

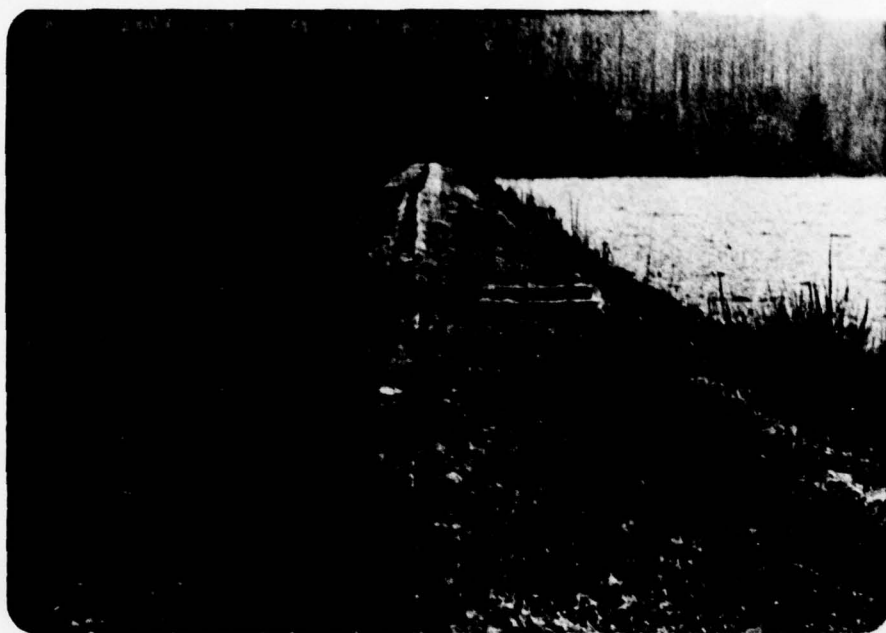
Photograph No. 1

Crest (looking south). Note concrete core wall.

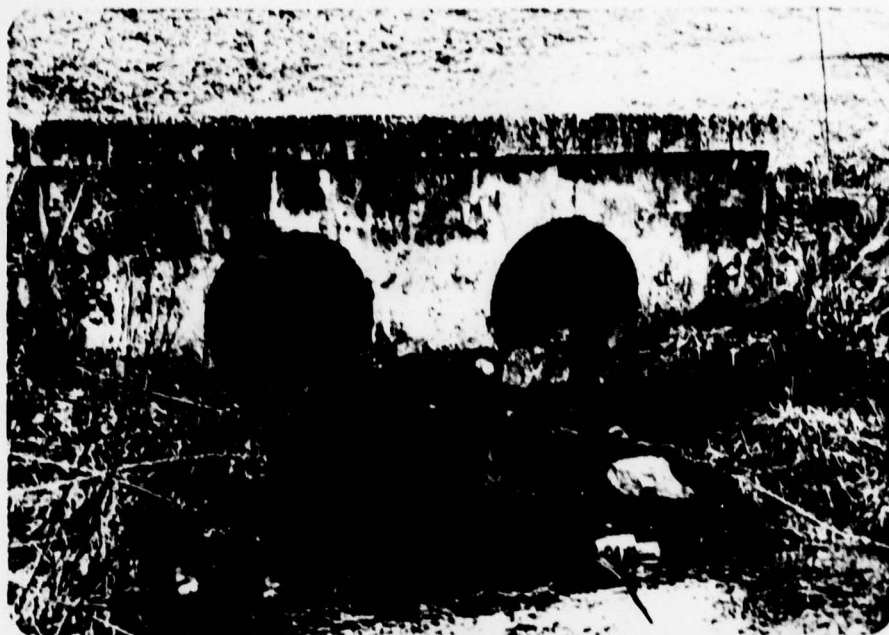
Photograph No. 5  
Outlet pipes.

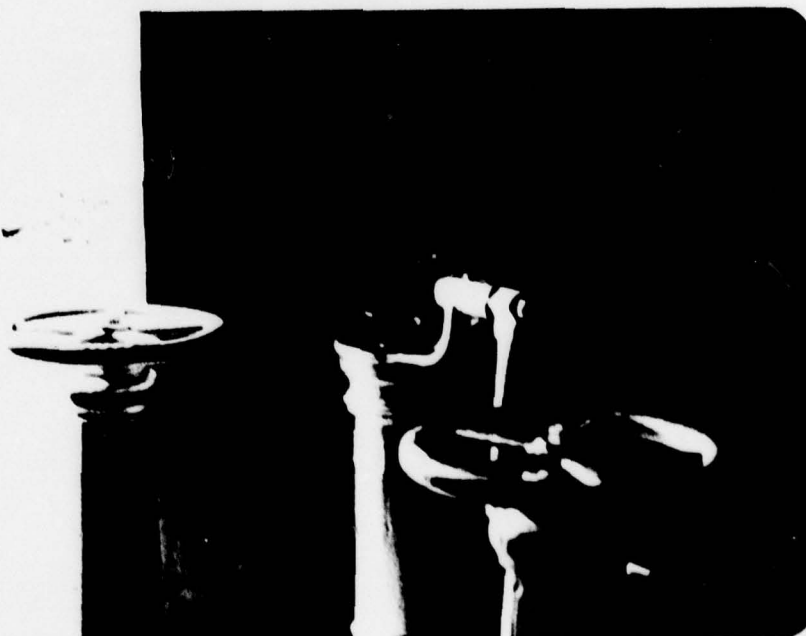
4.3 Maintenance of Operating Facilities. The maintenance condition of the operating facilities is considered to be good. However, Fish Commission personnel reported that the outlet conduit sluice gates have not been operated in the last several years. The operation of the sluice gates was not observed, because the operational condition of the gates was questionable.

Photograph No. 6  
Outlet pipe controls at intake tower.

4.5 Evaluation. The overall maintenance condition of the dam is considered to be good. However, the operational condition of the outlet conduit sluice gates was not observed. It is therefore recommended that the owner operate the sluice gates and perform necessary maintenance, as required. Periodic removal of vegetation from the upstream face of the dam is also recommended.

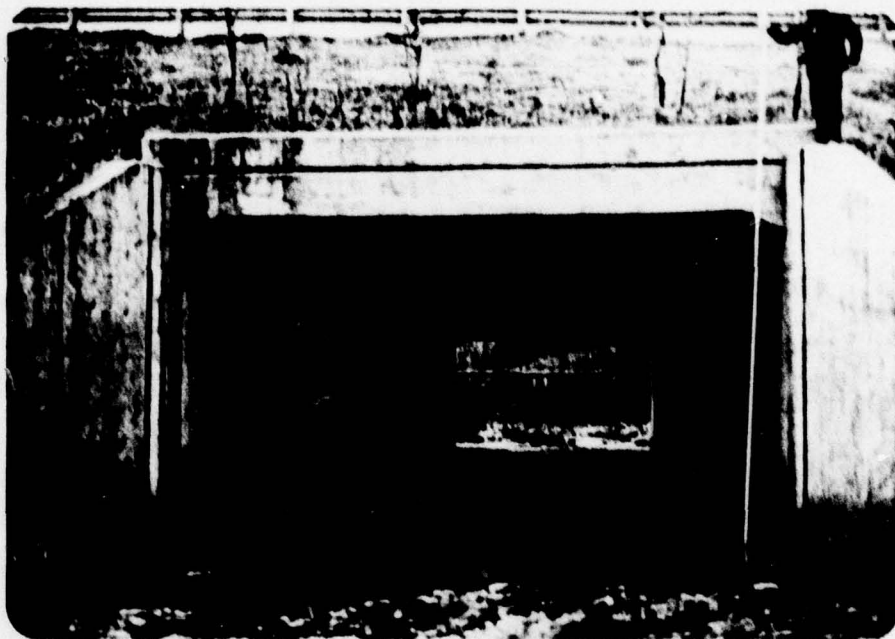
Photograph No. 7

Interstate Route 80 underpass (1000 feet downstream).
